STATE OF NORTH CAROLINA
DEPARTMENT OF TRANSPORTATION

Subject: **Application for Individual Section 404 and 401 permits**
For NC 109 from north of I-85 Business to north of SR 1798
(Old Greensboro Road), Davidson County, North Carolina
NCDOT Division 9
Federal Aid Project No STP-109(1)
State Project Number 8.1600901
TIP Project R-2568B
\$475.00 Debit work order 8.1600901, WBS Element 34634.1.2

The North Carolina Department of Transportation (NCDOT) proposes to relocate NC 109 from north of I-85 Business in Thomasville to north of SR 1798 (Old Greensboro Road), a distance of 3.51 miles. This section of existing NC 109 is located in the northeastern part of Davidson County. This Urban Principal Arterial is proposed to be a four-lane divided facility with partial access control, and will be constructed partially on new location. The typical section for the proposed facility includes a 46-foot grassed median. This application consists of the cover letter, 8 ½ x 11-inch permit drawings (drawings, impact summary sheets, property owners, and mailing labels), ENG form 4345, Stormwater Management Plan, 4C minutes for permit drawing interagency review, 4C agency comments and post-meeting ac

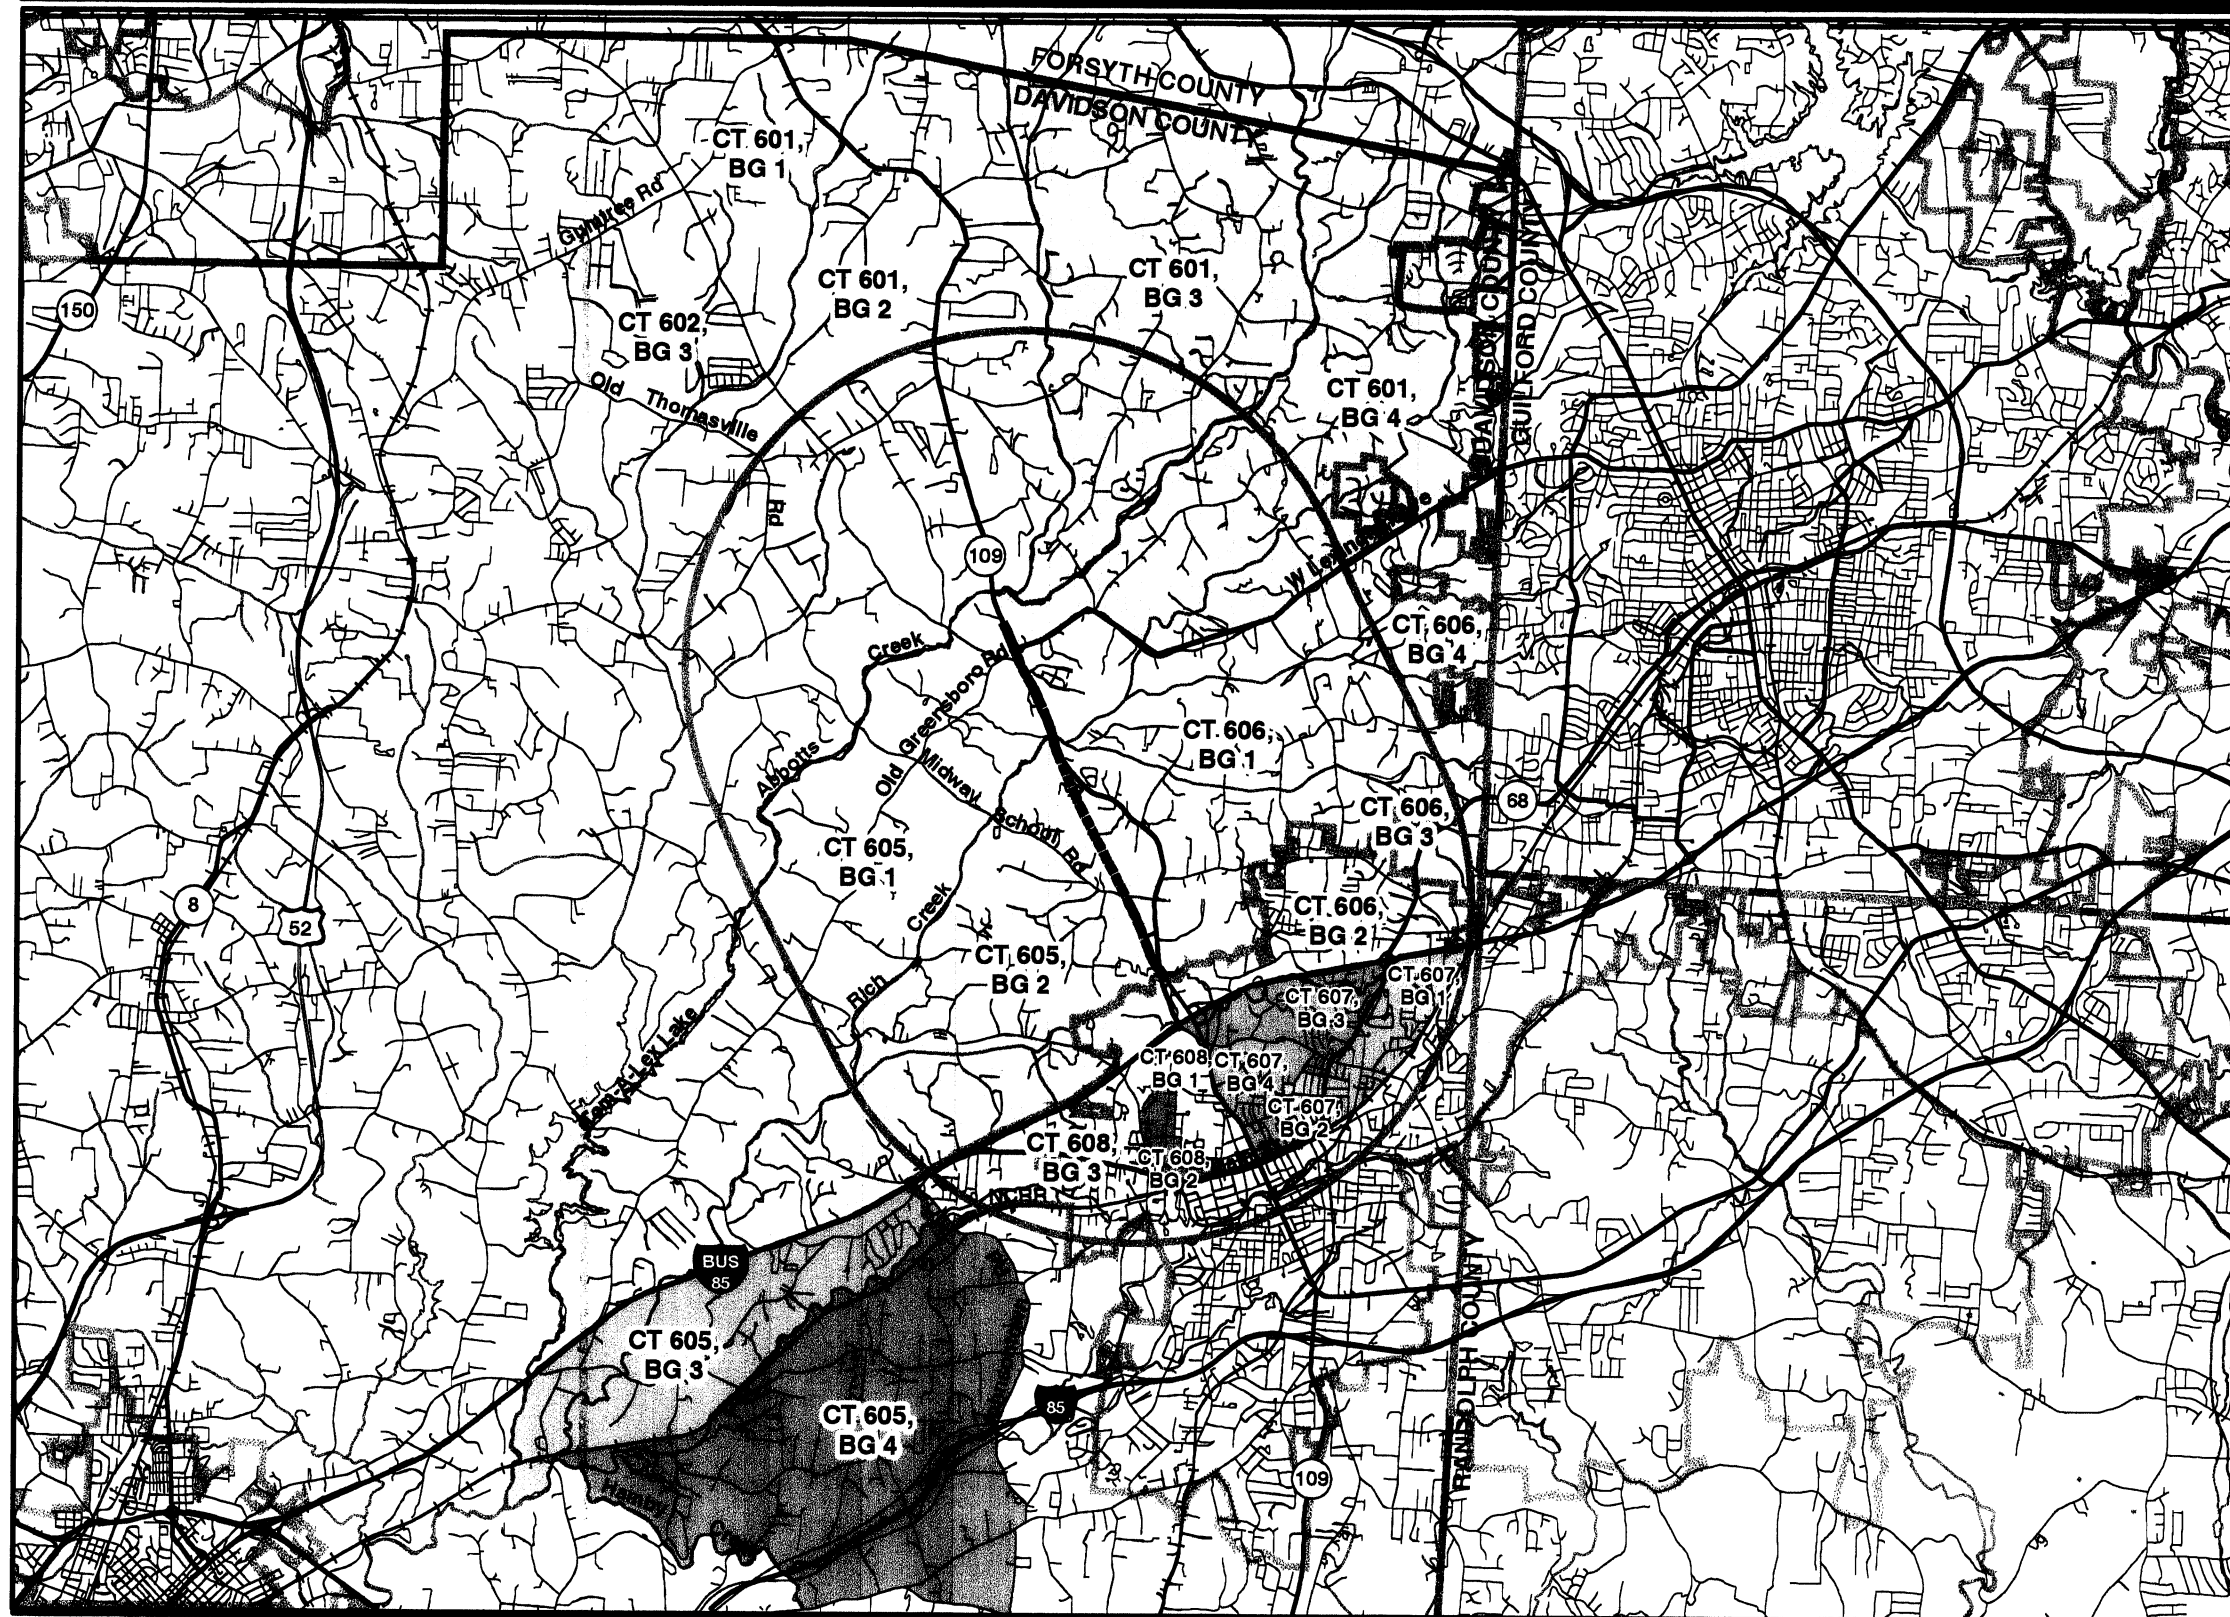
FIGURE 2 - DEMOGRAPHIC AREA

- TIP R-2568B
- HIGHWAYS
- ROADS
- RAILROADS
- RIVERS
- WATER BODIES
- COUNTY BOUNDARIES
- MUNICIPALITIES
- GROWTH IMPACT STUDY AREA

The North Carolina DOT's and North Carolina Department of Environment and Natural Resources' (DENR) *Guidance for Assessing Indirect and Cumulative Impacts of Transportation Projects in North Carolina* indicates that the development effects of a new roadway facility are most often found up to one mile around an interchange, and up to two to five miles along major feeder roadways to the interchange. Based on this guidance and an initial review of project area conditions, it was determined that the potential for growth impact as a result of this project would primarily be within a three-mile radius of the project. This three-mile radius, referred to as the Growth Impact Study Area (GISA), determines the data collection and analysis area, but is not necessarily the extent to which growth impacts are expected to occur (see Figure 2).

The Demographic Area for TIP R-2568B is partially located within Davidson County, the City of Thomasville, and the City of High Point. It was created to assess the socioeconomic growth trends within the GISA, which the Demographic Area encompasses (see Figure 2). This area is generally bounded by Old Thomasville Road, Abbotts Creek, Tom-A-Lex Lake, and Hamby Creek to the west, the Davidson/Forsyth County Line to the north, the Davidson/Randolph County Line and Rich Creek to the east, and North Carolina Railroad (NCRR), SR 2031, Cunningham Road, SR 2118, and SR 2010 to the south. The following 2000 US Census Bureau Census Tracts (CT) and Block Groups (BG) are included in the Demographic Area for TIP R-2568B:

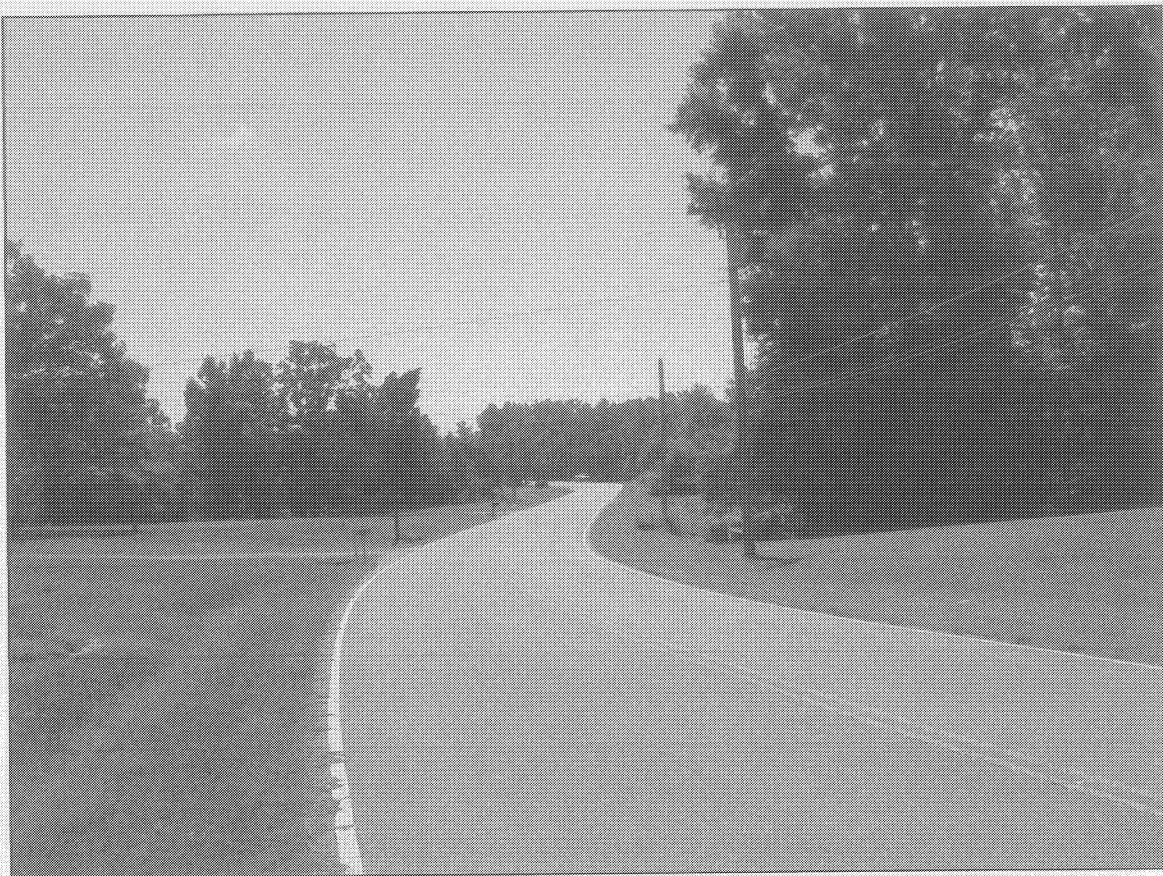
Midway School Road, Looking East Where The New NC 109 Will Cross

The greatest potential for induced commercial growth is at the new intersection of NC 109 and Midway School Road. This location is the only major new intersection created by the portion of NC 109 that is on new alignment, and developable land will be available at this intersection. Midway School Road is also a main route to the west, and will connect to existing NC 109 to the east as well. Both sides of Midway School Road, just west of existing NC 109 are designated as potential Sewer Service Area.
